WRDC-TR-90-2120

INVESTIGATION INTO THE FAILURE CAUSE OF A
DOUBLE ACTING, LEADING EDGE GROOVE,
TILTING PAD THRUST BEARING

October 1990

AERO PROPULSION AND POWER LABORATORY
WRIGHT RESEARCH AND DEVELOPMENT CENTER
AIR FORCE SYSTEMS COMMAND
WRIGHT-PATTERSON AIR FORCE BASE, OHIO 45433-6563

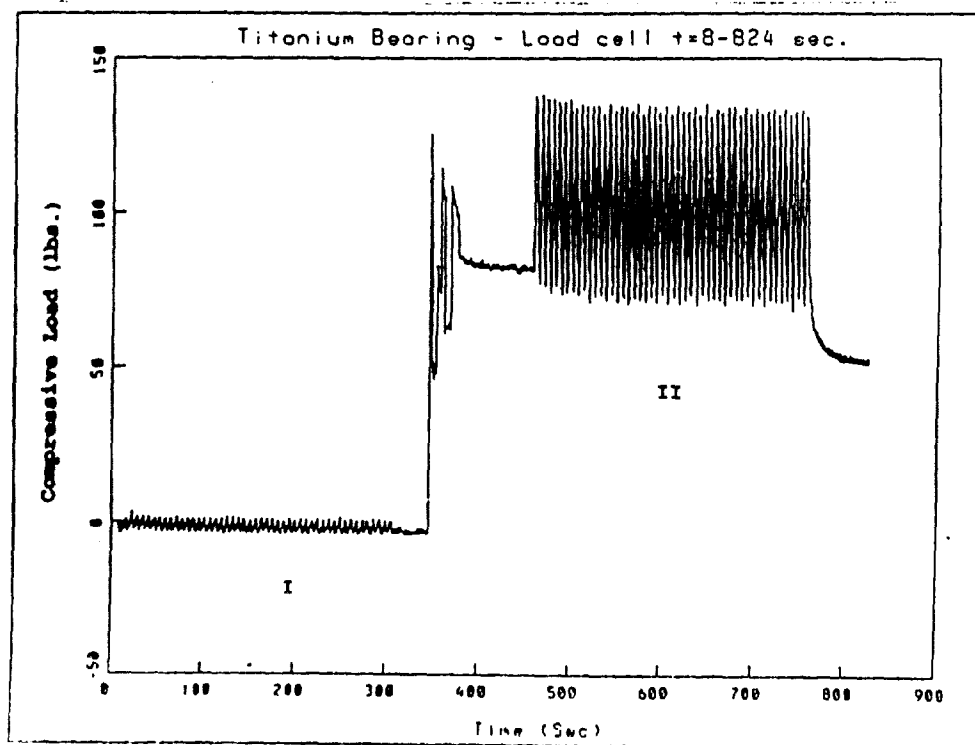
Figure 4.6 Compressive Load Cell Results
Test Segments I and II

(1) Test Segments I and II Load cell data from test segments I and II are presented in Figure 4.6. These results show a cyclic loading present in all the data taken. The frequency of the cyclic loading is the same as the frequency of the rotating collar, indicating that it is due to the runout of the collar. The cyclic loading was not of sufficient magnitude and duration to cause fatigue of the babbitt. This was proven later during the third bench test when examination of the cross section of a failed area revealed no subsurface cracking.

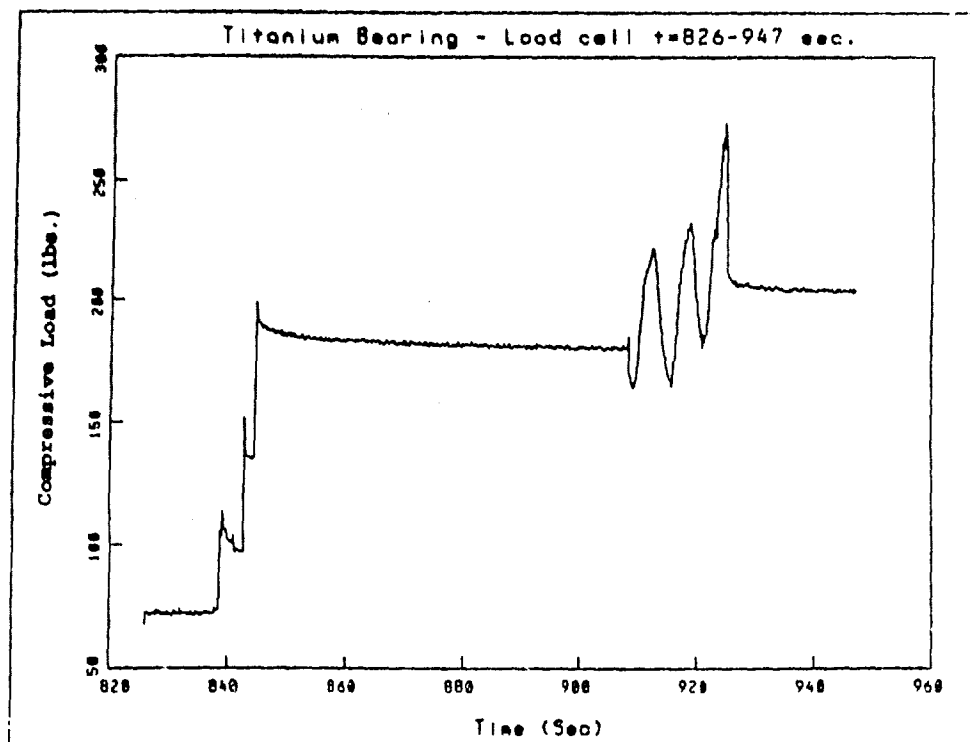
Figure 4.7a Test Segment IIIa

(2) Test Segments III and IV Test segment III was divided into two portions, IIIa and IIIb, and is presented in Figures 4.7a and 4.7b. After approximately 20 seconds into segment III, enough torque was generated to turn the bearing pad slightly. The torque was caused by the radial variations in frictional load because of the change in thrust collar velocity and the distance slid with radial location. The test was halted and a stop was added to counteract the torque. Testing was restarted and the load cycle magnitude increased because of an increased offset in the thrust collar runout. Test segment III was not of sufficient duration to initiate babbitt fatigue.

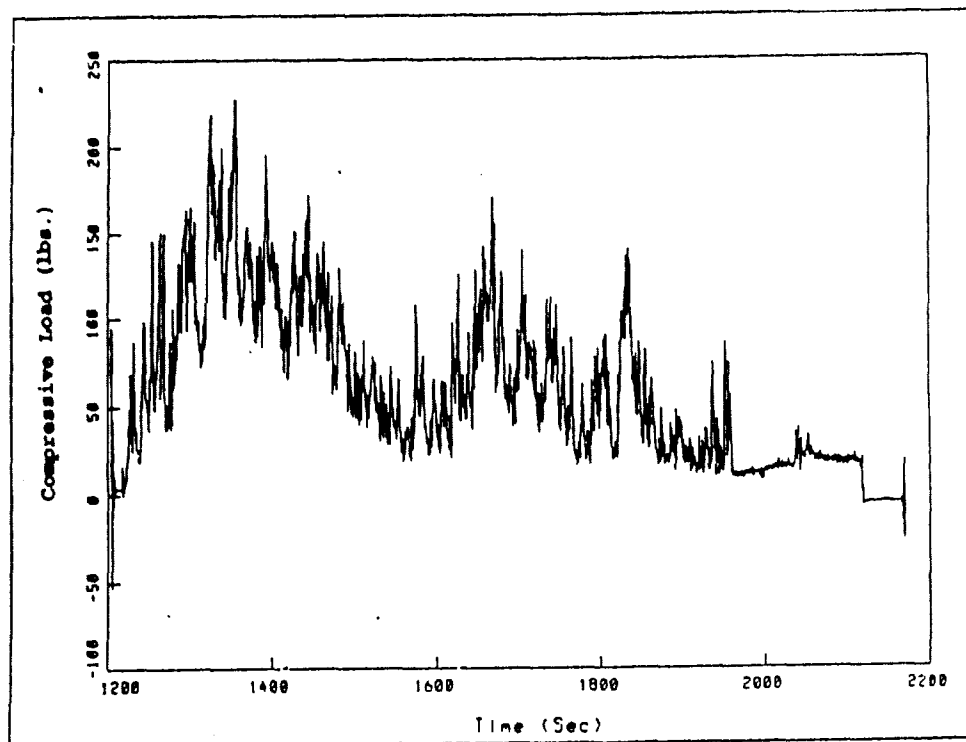
Figure 4.8a Compressive Load Cell Results
Test Segment IV

Load cell results from test segment IV are presented in Figures 4.8a and 4.8b. Bearing failure progressed rapidly during test segment IV because of the increased rotational speed and corresponding increased distance slid. Figure 4.8a presents the load cell data taken throughout test segment IV. Figure 4.8b presents the load cell data of the first 37 seconds of test segment IV. These figures show cyclic loading at three different frequencies. The most evident is the load cycle because of slight offset in the collar face runout, which has the highest frequency. The other two cycles do not have a constant frequency. The cyclic loading of the lowest magnitude frequency is evident in Figure 4.8a and is due to the clearing and generation of wear debris. The cyclic loading with the middle frequency is most visible in Figure 4.8b. Close examination of Figure 4.7b reveals that a frequency of the same order of magnitude was present

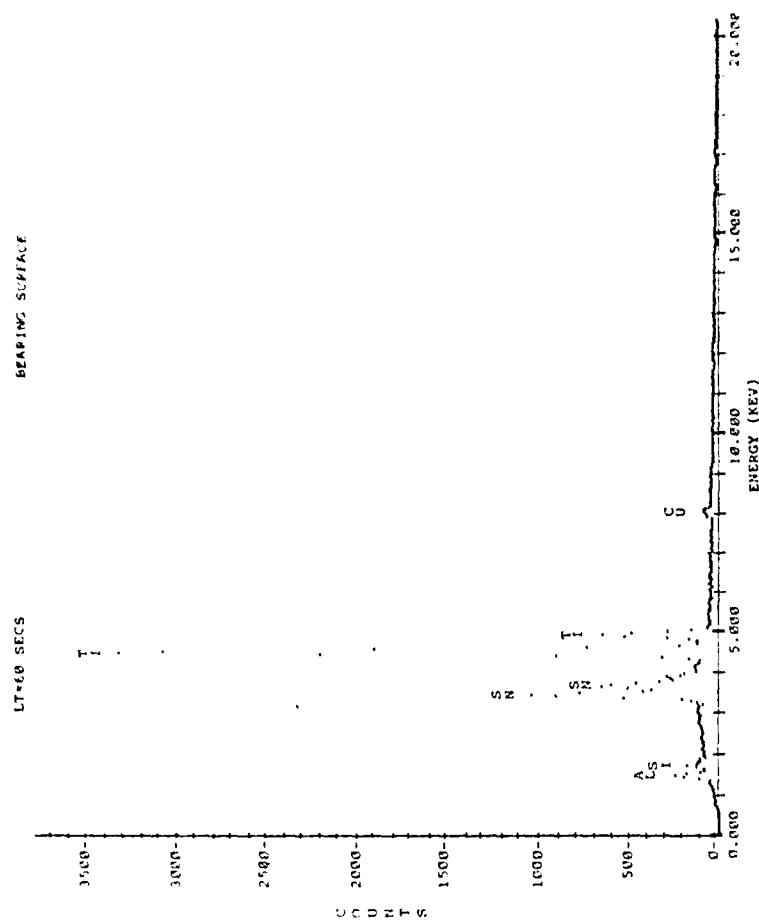
Figure 4.13b Smeared Failure Zone

Figure 4.13 provides a closer look at some areas in Figure 4.12, as well as element identification of the surfaces. Figure 4.13a shows one of the heavily smeared areas. X-ray diffraction results show a large titanium peak, as well as tin, aluminum, silicon, and copper peaks. Figure 4.13b shows one of the flaked areas. Again, a large titanium peak is evident, along with tin, aluminum, silicon, and copper peaks. The bottom, left corner of Figure 4.13b shows a pit created by galling. Figure 4.13c is a photograph of this area. The magnification reading and scale printed on the photo should be disregarded. Titanium is the predominant peak of the element identification.

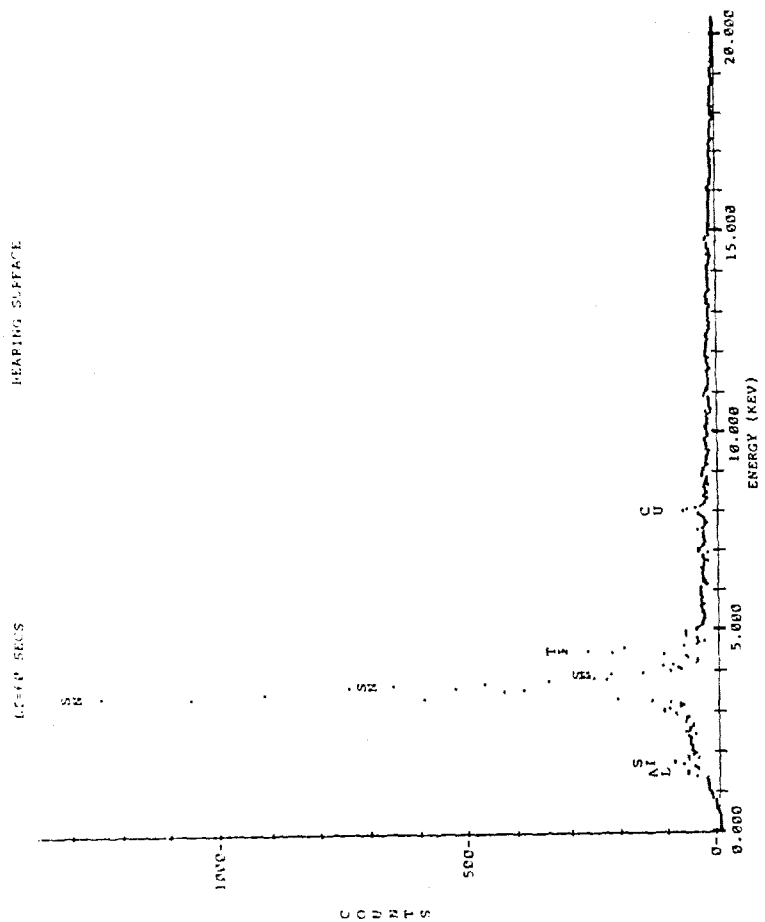
Figure 4.13e Abrasive Wear Track

The tin, aluminum, silicon, and copper peaks are sharper than in 4.13b, particularly the silicon peak. Another of the pitted areas is shown in Figure 4.13d. Aluminum, silicon, and calcium are present, a definite indication of foreign particle contamination, but no foreign particle is visible. This area is clearly visible in Figure 4.12. Figure 4.13e shows a wear track produced during the test. The wear track is 0.0028 inch wide. This wear track can be seen at the bottom center of Figure 4.12. Tin is the primary elemental component, with the elements titanium, aluminum, silicon, and copper again present.

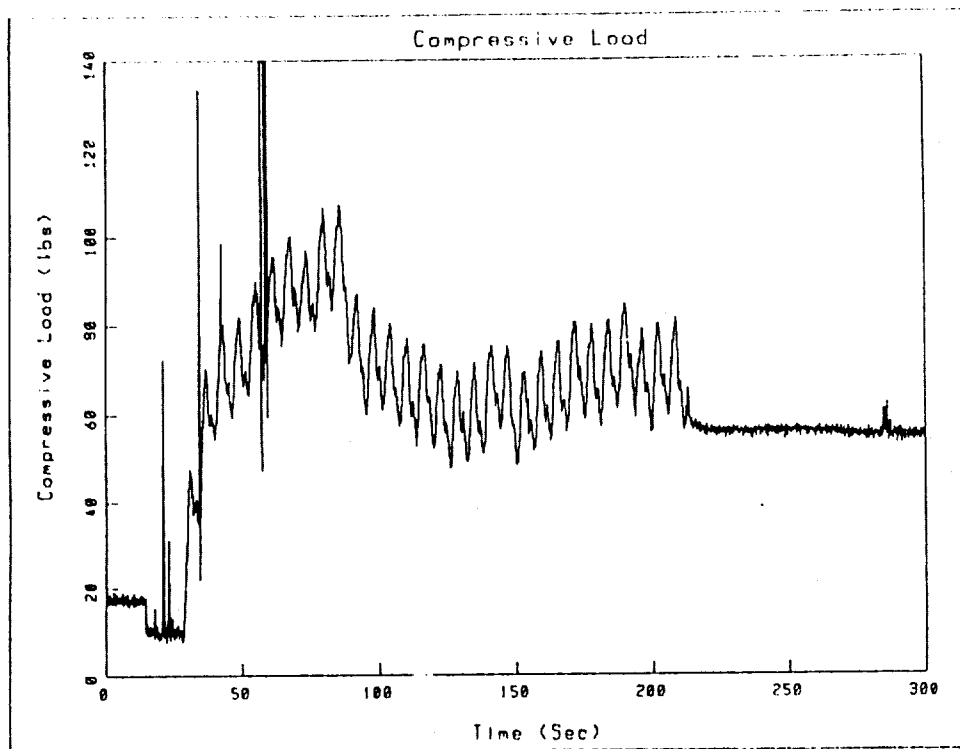
Figure 4.17 Compressive Load Results - Bench Test 3

first bench test. Figure 4.17 shows that two load cycle frequencies are present; the frequency which matches the frequency of collar rotation owing to collar runout, and a lower frequency. When the basis for the frequency is cycles per distance slid rather than cycles per unit time, the frequency is of the same order of magnitude as the middle frequency found in test segment IV. The sharp spikes on the plot are caused by the analog tape recorder.

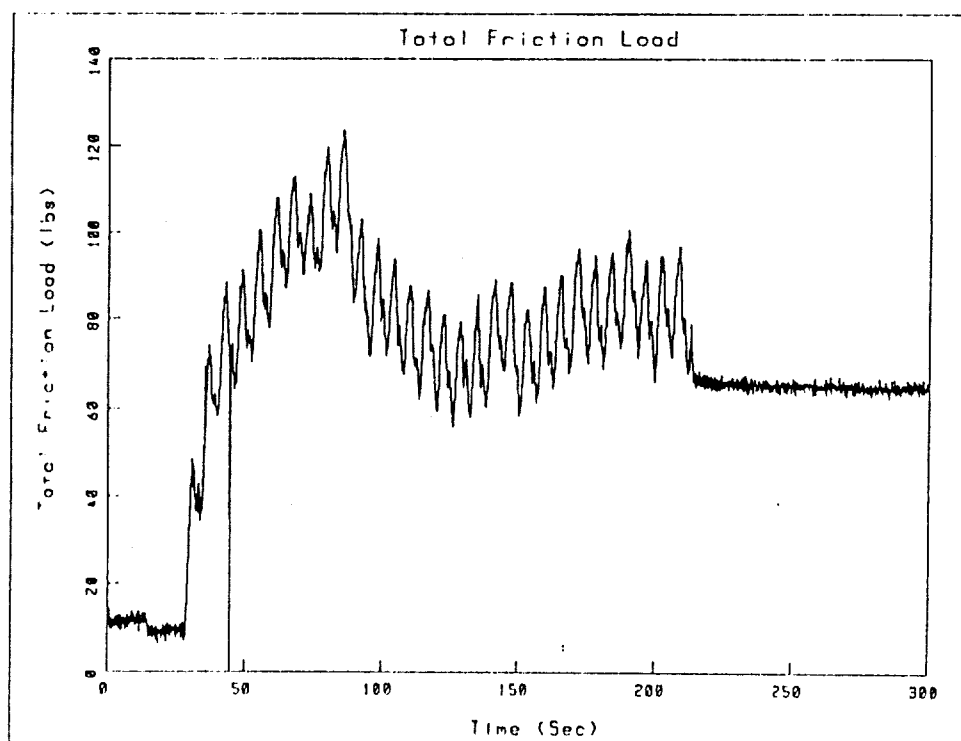
Figure 4.18 Friction Load Results - Bench Test 3

Frictional load measurements provided by the second load cell and the cantilever beam are presented in Figure 4.18. The results presented in Figures 4.17 and 4.18 provide a rough estimate of the friction coefficient of the material combination. The friction coefficient variation with time, and consequently distance slid, is presented in Figure 4.19. Because of the small static load applied, instrumentation noise and the limited accuracy of the load cells, the static coefficient of friction could not be determined with any confidence. However, dynamic coefficient of friction, and its variation with time and distance slid could be determined with limited confidence. The coefficient of friction reached a peak of 1.2 after 125 seconds (19.4 revolutions).
